Allied Paper, Inc./ Portage Creek/  
Kalamazoo River Superfund Site

## Former Plainwell Impoundment 2010 Bank Conditions Monitoring Report

Georgia-Pacific LLC

April 2011

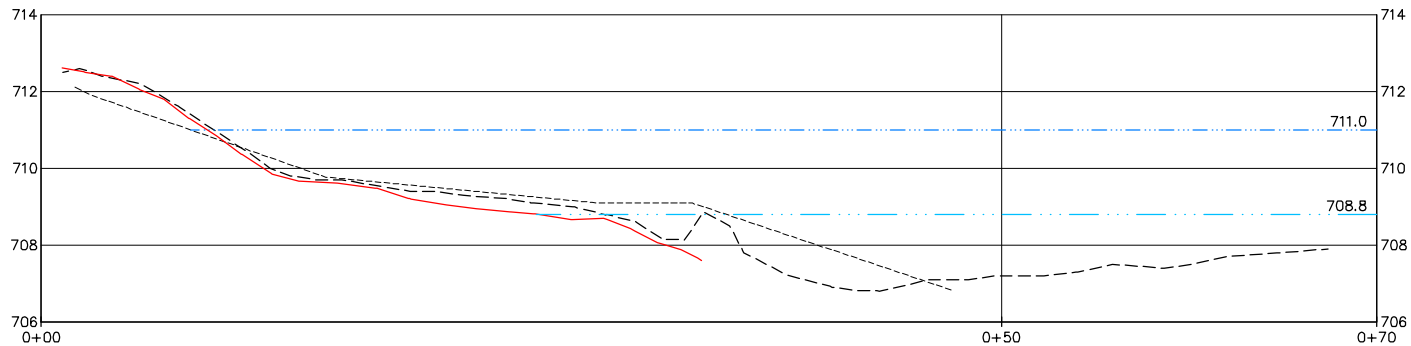
**T-4N (NORTH BANK)**

- T-4N – This transect is located on the north bank in Removal Area 5A. The bank at this location currently appears very similar to the geometry observed in 2009. The 2010 survey did not extend to the toe of slope to enable an assessment of its stability. Overall, this bank is currently characterized as stable.

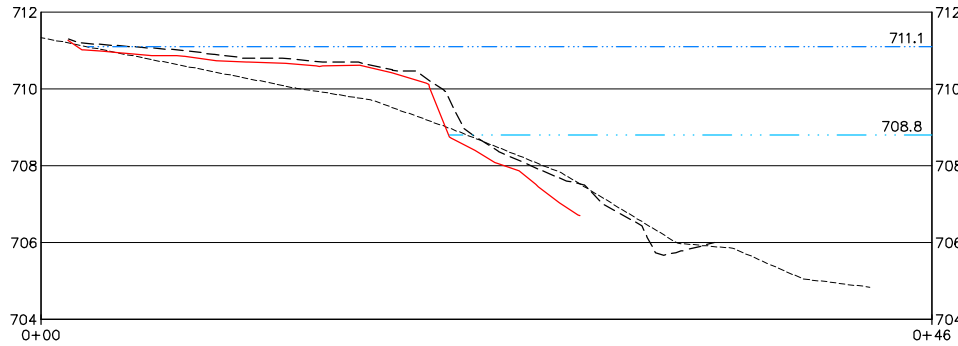
**T-4S (SOUTH BANK)**  
SCALE AS NOTED

- T-4S – This transect is located on the south bank in Removal Area 4B. The accumulation of sediment at the top-of-bank that was observed in 2009 exhibits some slight erosion and bank steepening. The lower portion of the bank exhibits a stable slope but also shows signs of some lateral erosion. The 2010 survey did not extend to the bank toe to enable an assessment of its stability. Overall, this portion of the bank is remaining stable.

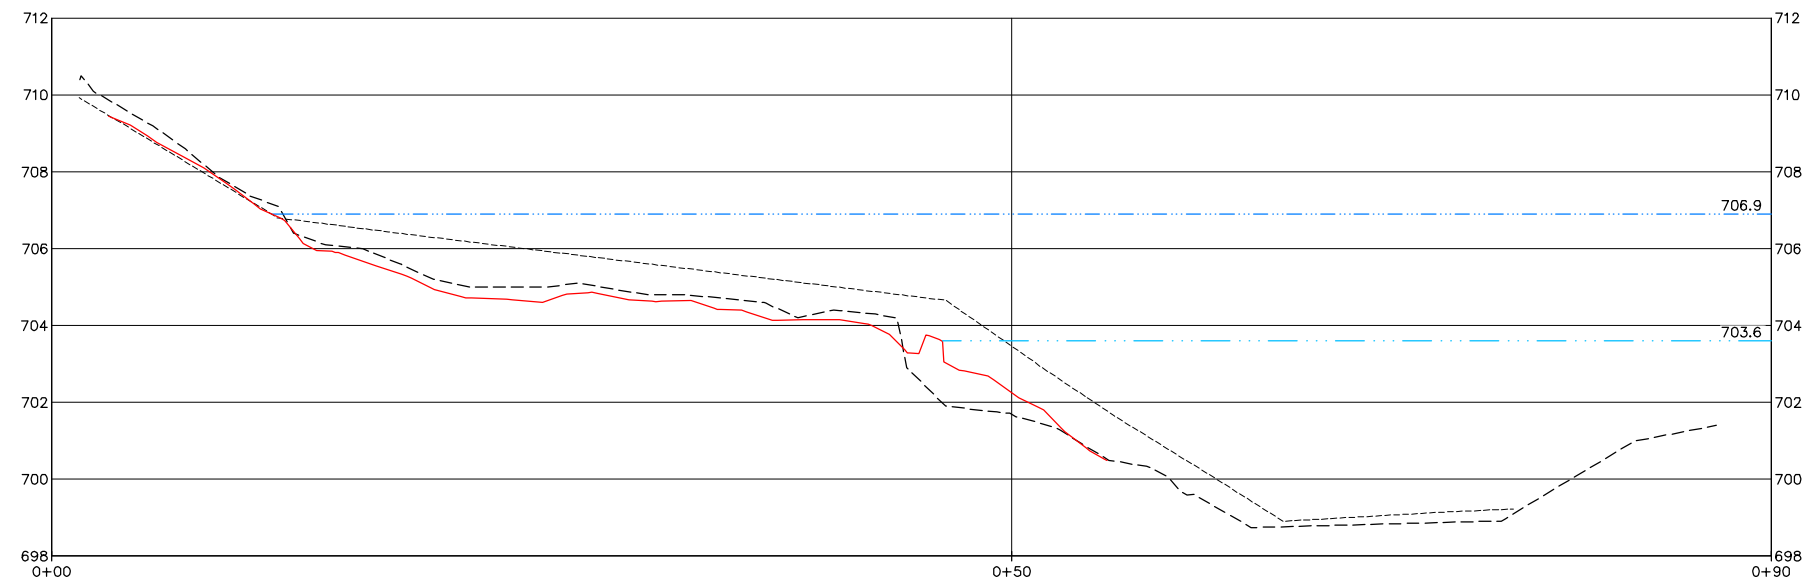
**T-8S (SOUTH BANK)**  
SCALE AS NOTED

- T-8S – This transect is located on the south bank in Removal Area 9B. Some significant erosion was concluded to be occurring at this location in 2009, as evidenced by the loss of the designed slope and a steepening of the bank angle at the median water level. Therefore, this portion of the south bank was repaired in 2009 by the addition of rock at the toe and the installation of a coir log at the prism-out median water elevation to protect the lower bank shelf. The coir log, ~~is visible on the cross-section~~ should assist in the accumulation of sediment on the upper portion of the bank. Following the repair, the portion of the bank immediately below the median water elevation is currently at a stable slope. ~~The coir log should assist in the accumulation of sediment on the upper portion of the bank.~~ This bank is currently characterized as stable.

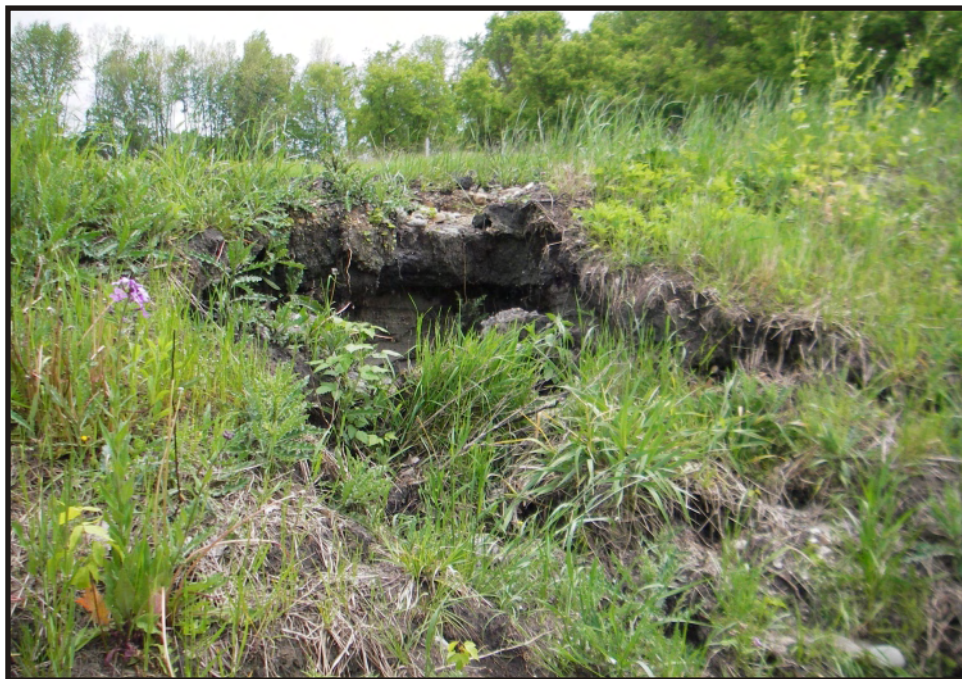
Area of south bank in Removal Area 9B requiring repair.

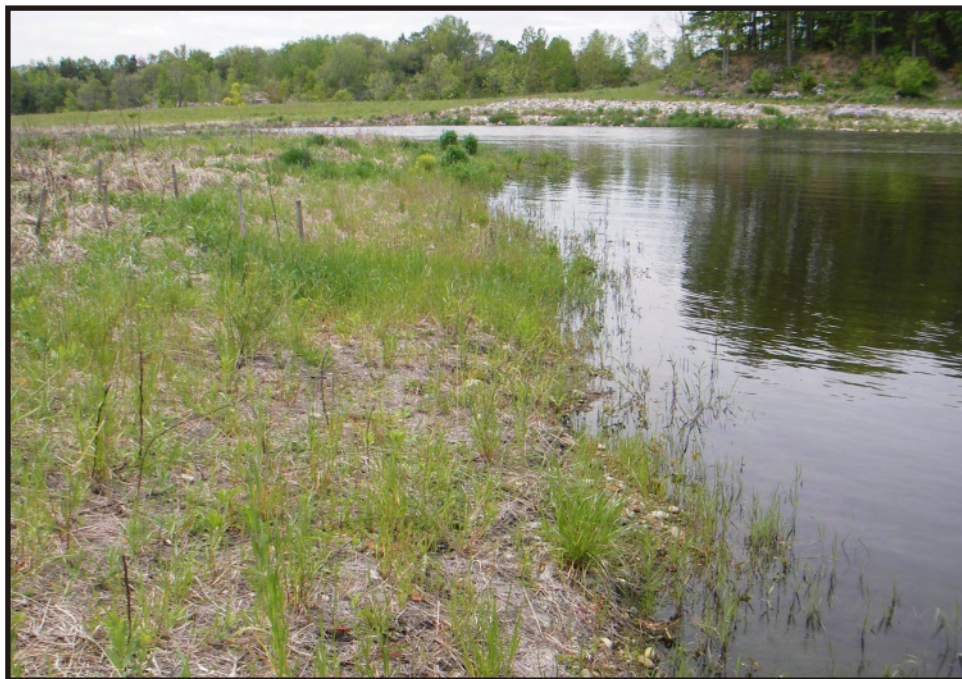
1

**Photo #1:** BEHI Area B1 (Low Erosion Potential) on north bank upstream of the former Plainwell Dam, looking southwest.

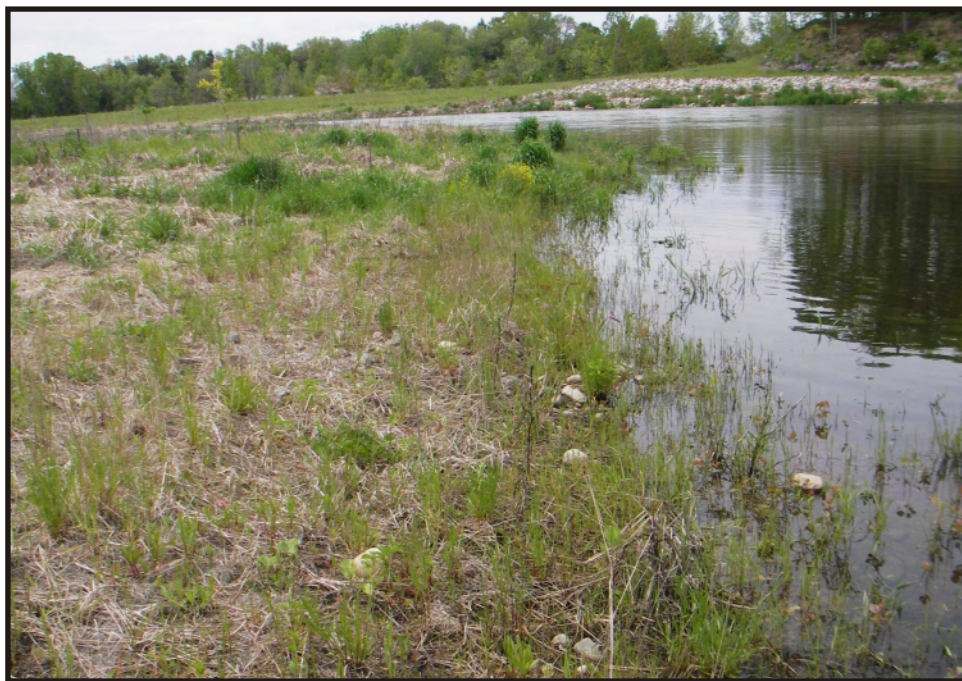
2

**Photo #2:** BEHI Area C1 (Low Erosion Potential) on north bank upstream of the former Plainwell Dam, looking southeast.

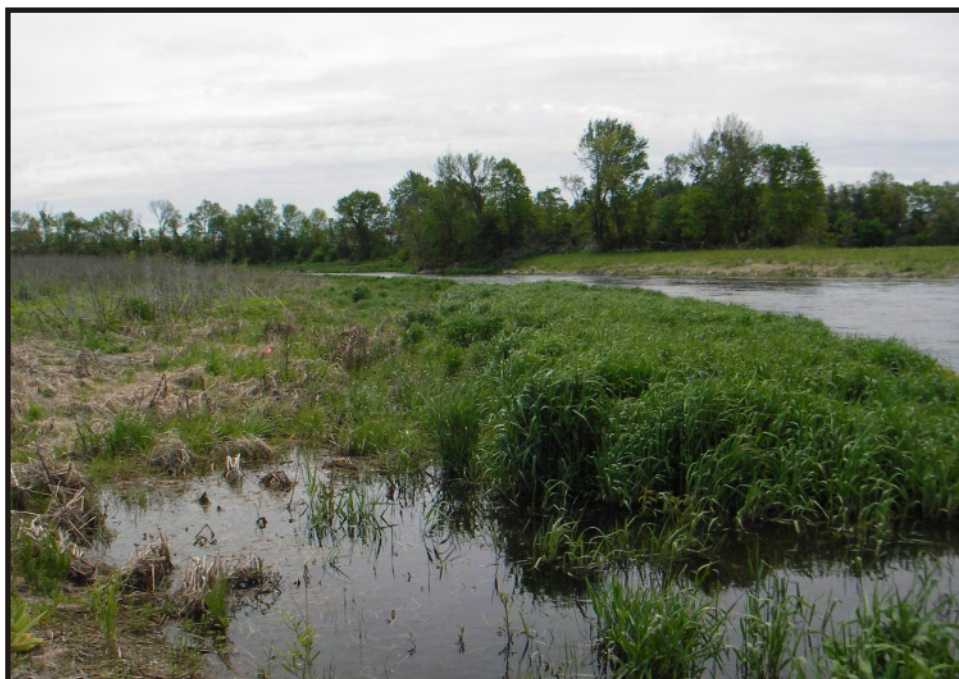
3

**Photo #3:** BEHI Area D1 (Very Low Erosion Potential) on north bank upstream of the former Plainwell Dam, looking southeast.

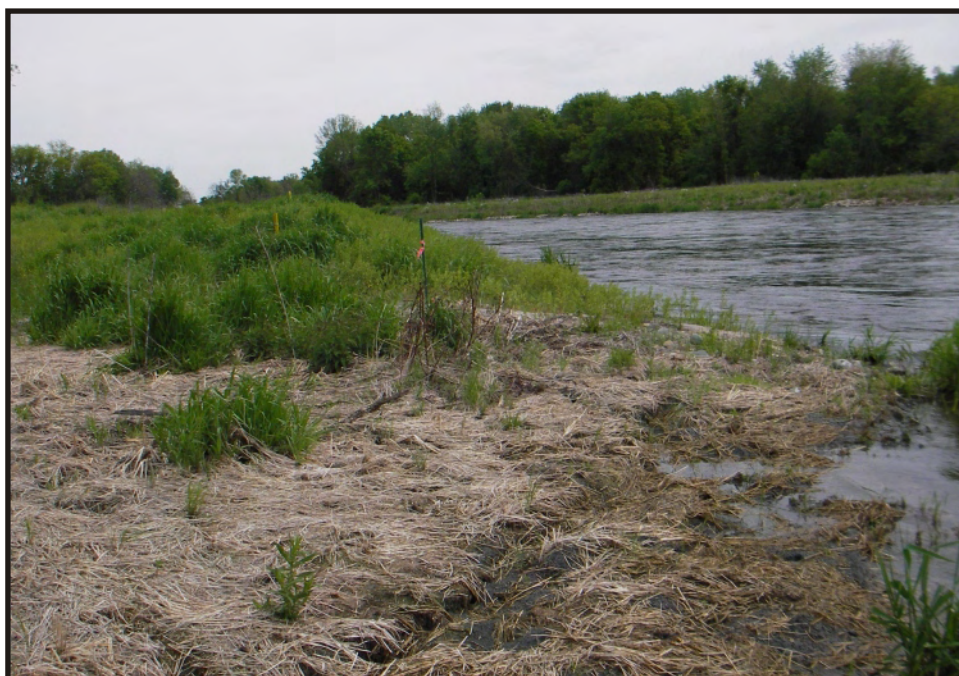
4

**Photo #4:** BEHI Area D (Very Low Erosion Potential) on north bank upstream of the former Plainwell Dam, looking east.

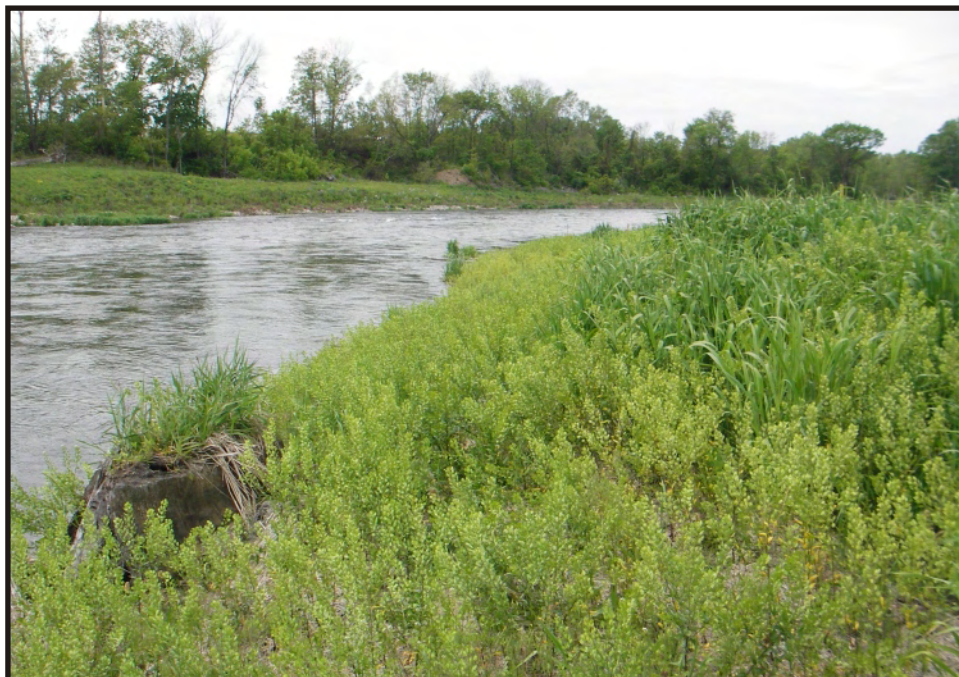
5

**Photo #5:** BEHI Area E1 (Moderate Erosion Potential) on north bank at the regraded gas pipeline, looking southwest.

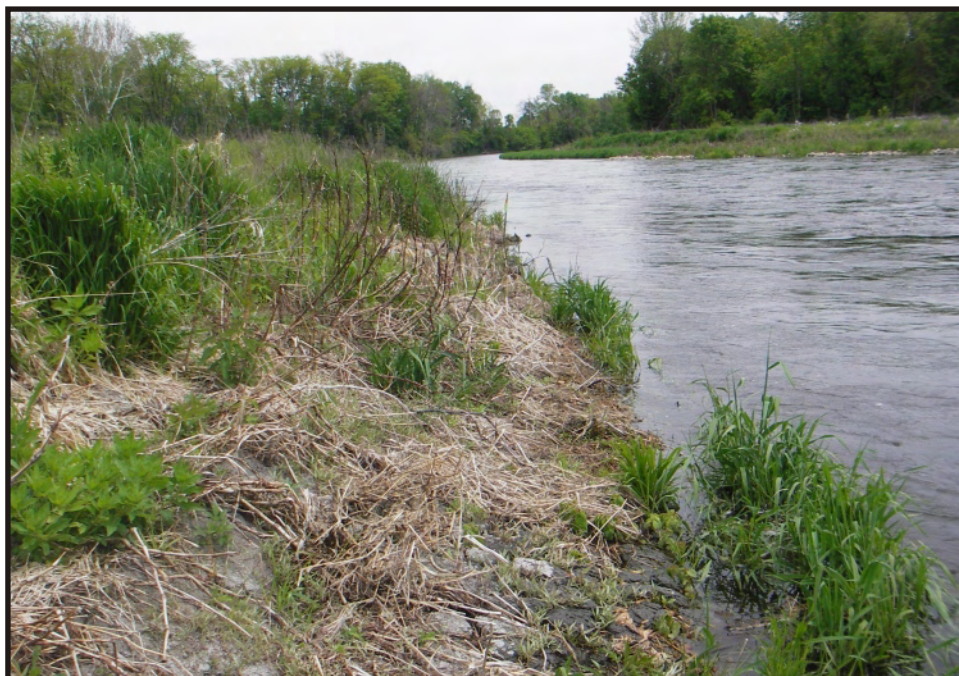
6

**Photo #6:** BEHI Area G1 (Moderate Erosion Potential) on north bank upstream of the gas pipeline, looking northeast.

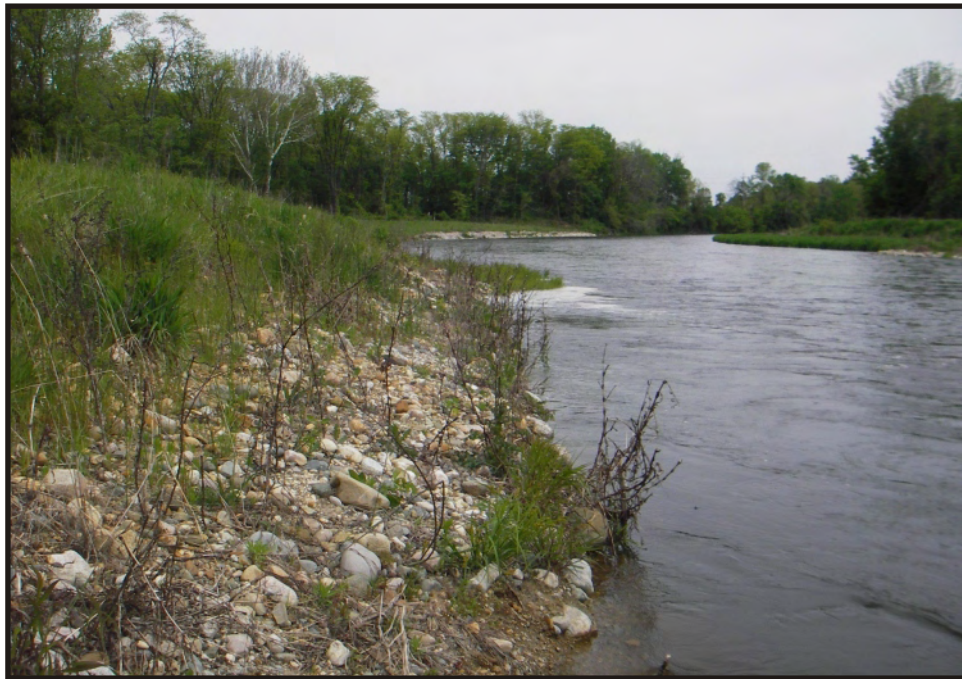
7

**Photo #7:** BEHI Area H1 (Very Low Erosion Potential) on north bank, looking east.

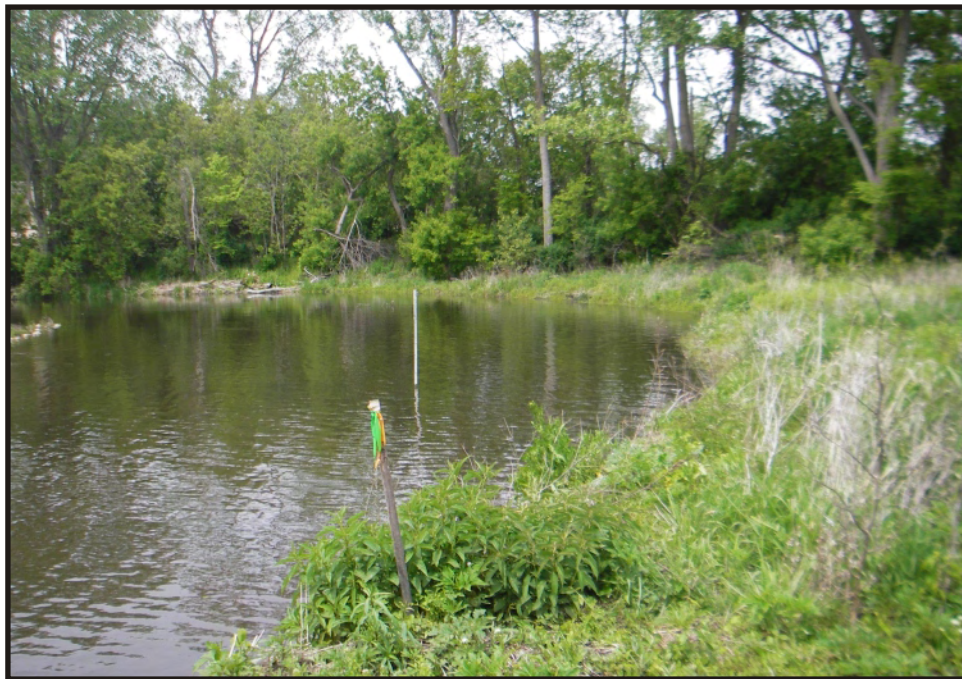
10

**Photo #10:** BEHI Area I2 (Very Low Erosion Potential) on north bank immediately upstream of the US-131 bridge, looking north.

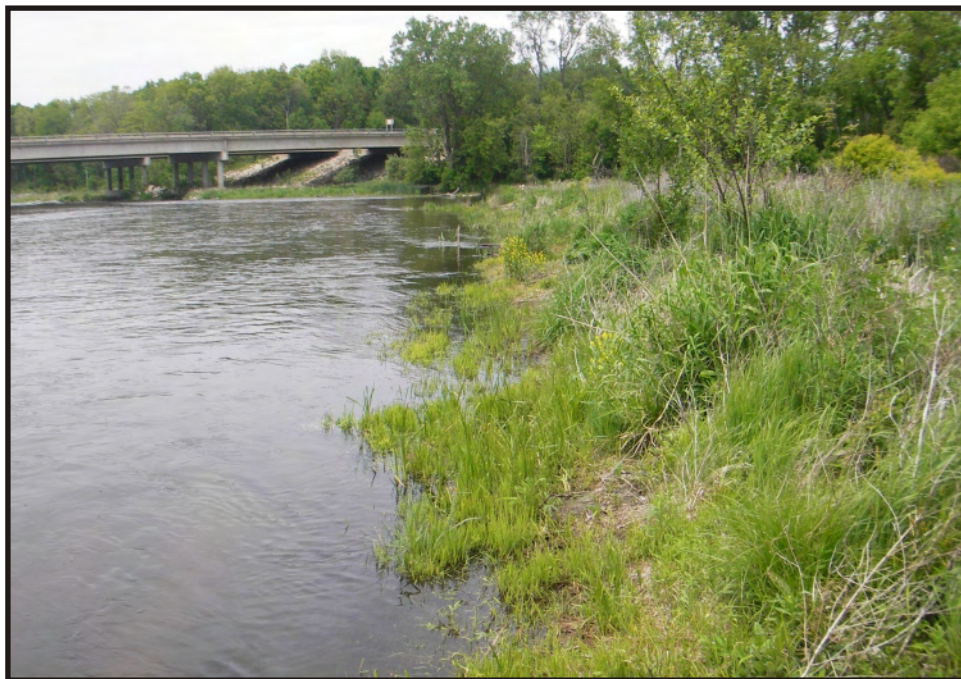
11

**Photo #11:** BEHI Area I2 (Very Low Erosion Potential) on north bank upstream of the US-131 bridge, looking northwest.

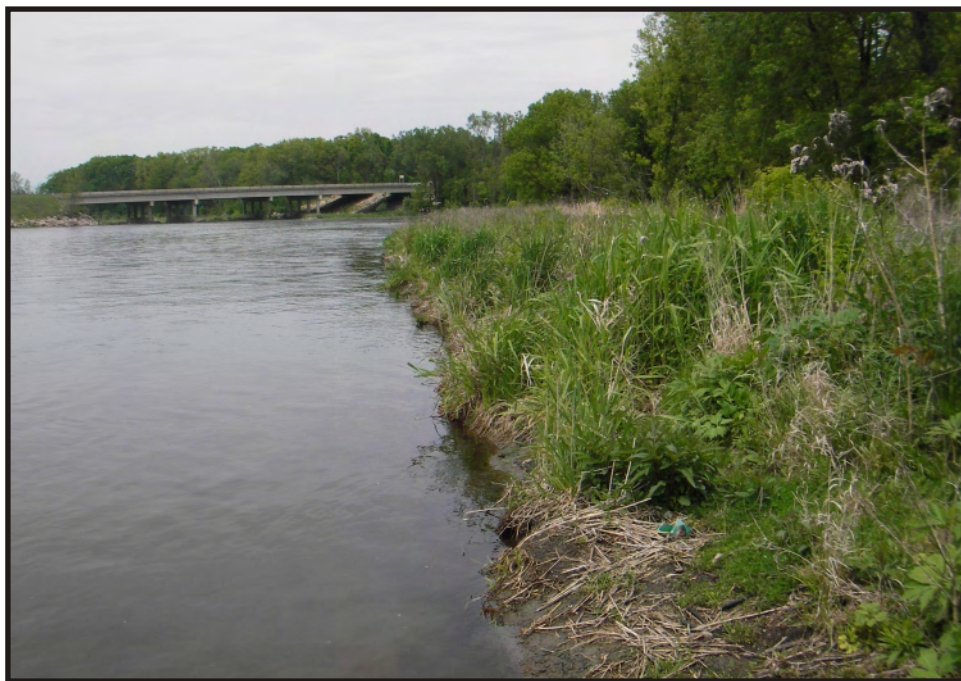
12

**Photo #12:** BEHI Area I2 (East) (Moderate Erosion Potential) on north bank immediately upstream of the US-131 bridge, looking northwest.

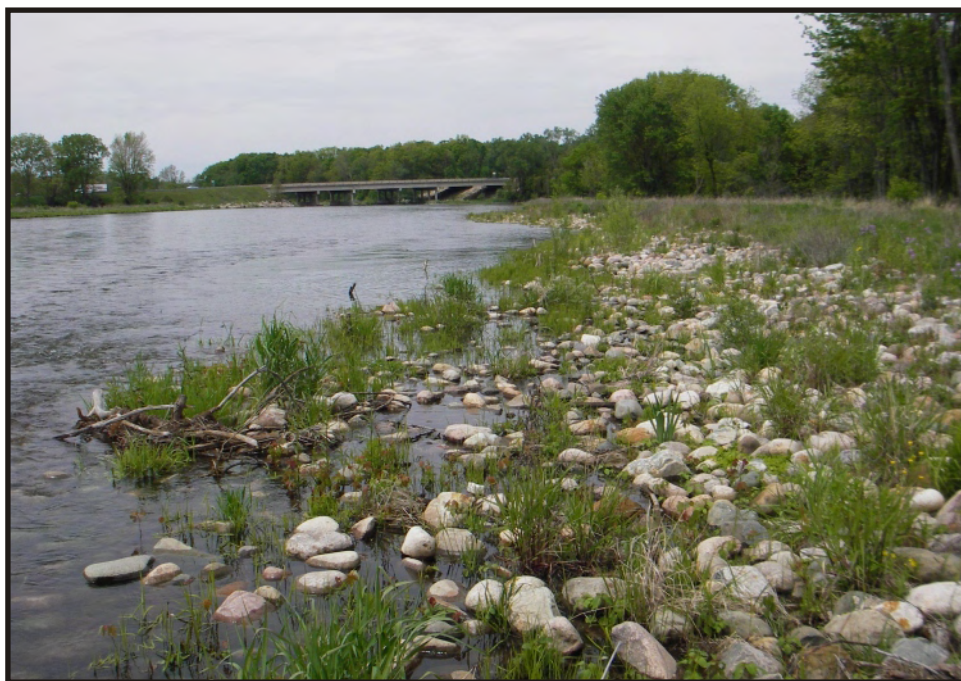
**13**

**Photo #13:** BEHI Area H2 (Very Low Erosion Potential) on north bank upstream of the US-131 bridge, looking northwest.

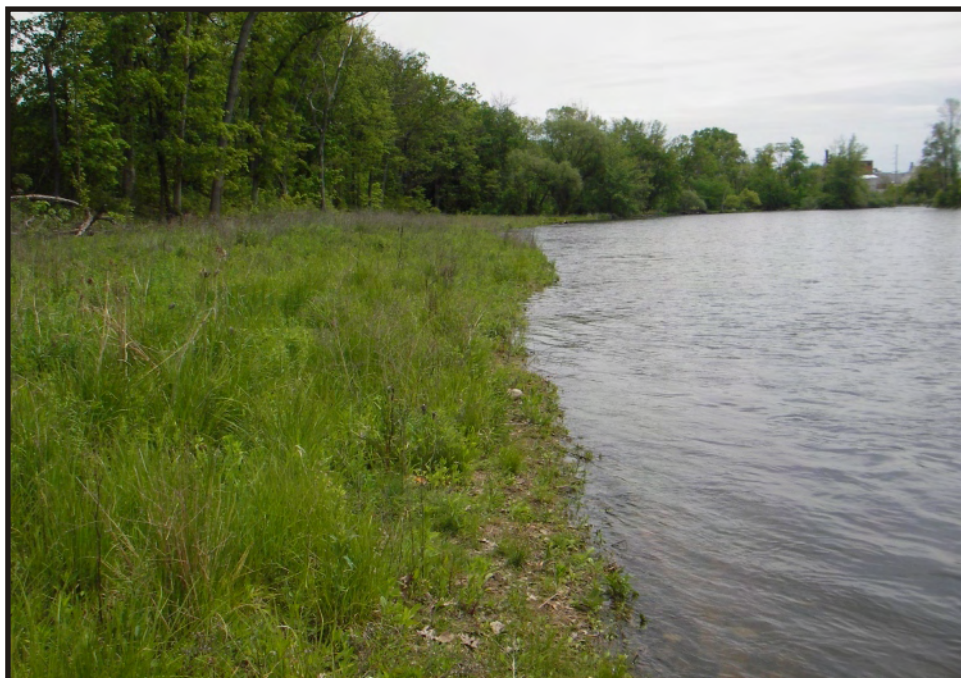
**14**

**Photo #14:** BEHI Area I1 (Very Low Erosion Potential) on north bank upstream of the US-131 bridge, looking southeast.

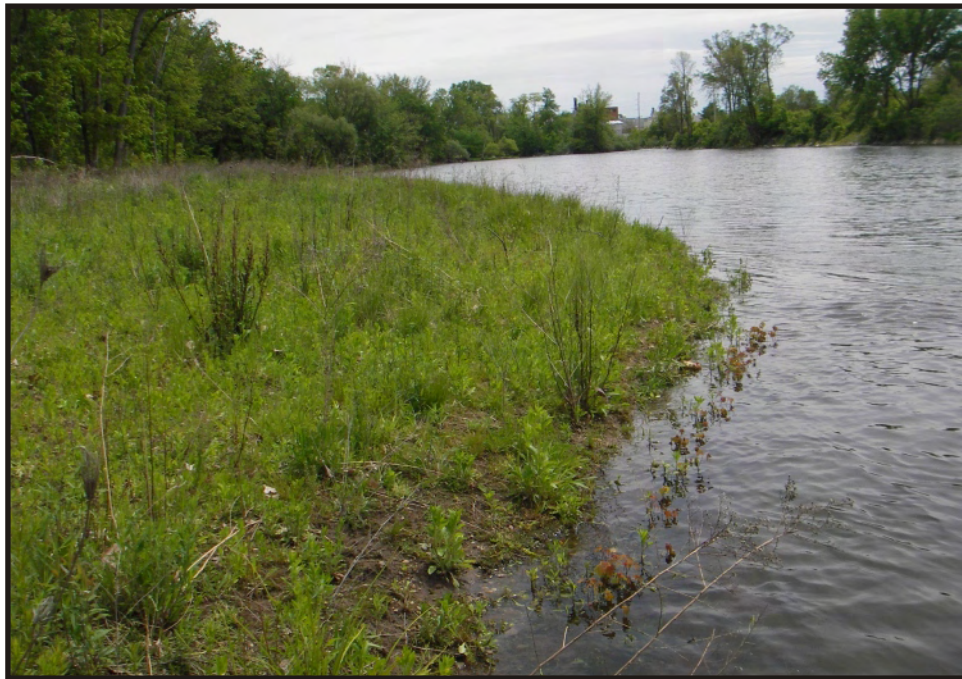
**15**

**Photo #15:** BEHI Area I1 (Very Low Erosion Potential) on north bank upstream of the US-131 bridge, looking southeast.

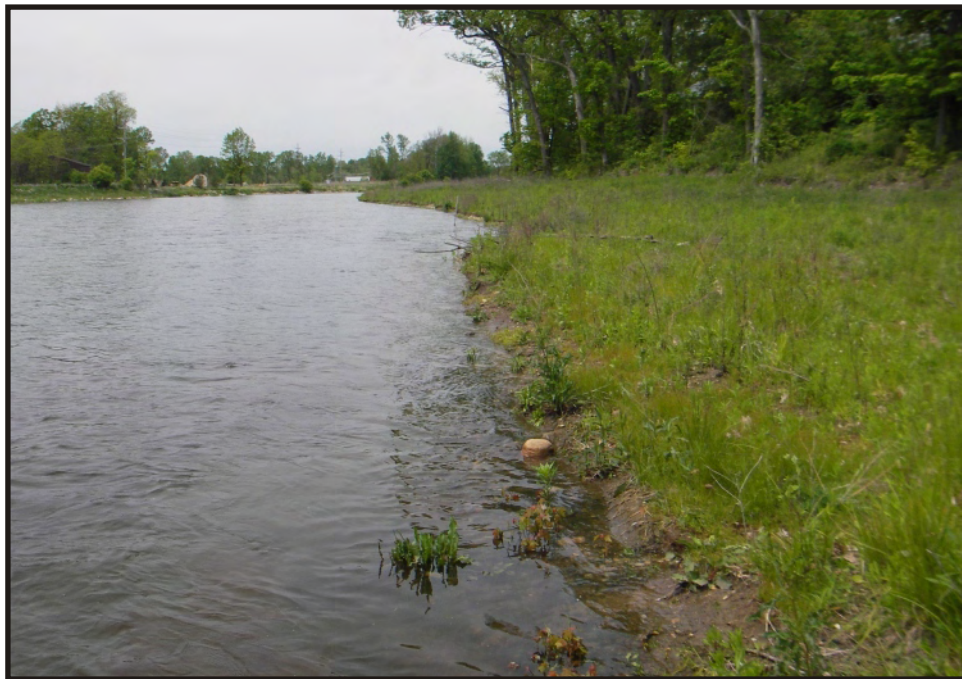
**16**

**Photo #16:** BEHI Area I1 (Very Low Erosion Potential) on north bank, looking northwest from upstream end.

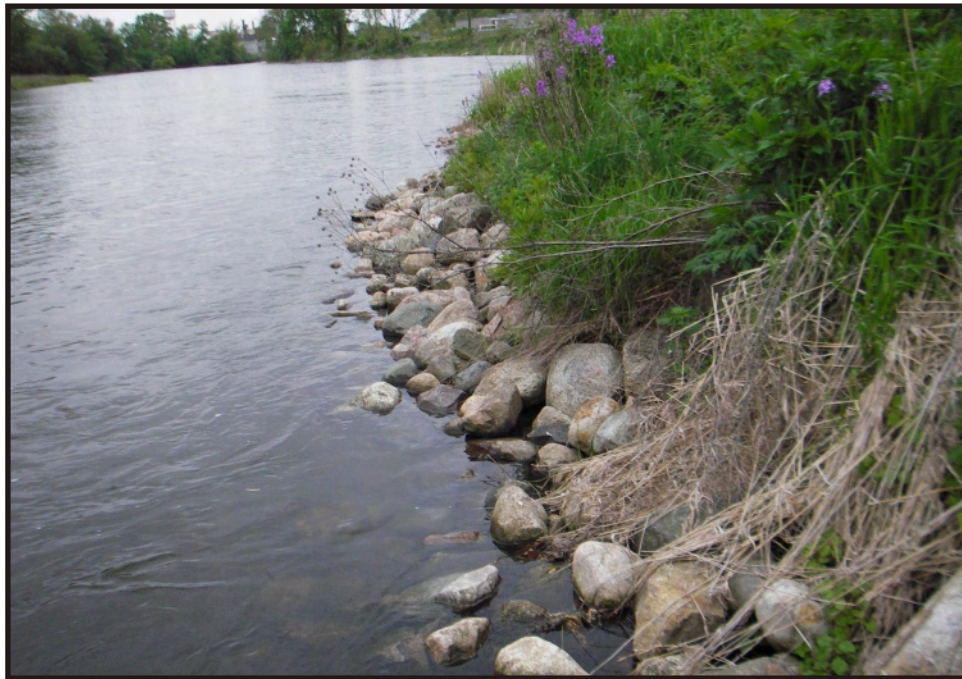
**17**

**Photo #17:** BEHI Area O (Low Erosion Potential) on south bank upstream of the US-131 bridge, looking southeast.

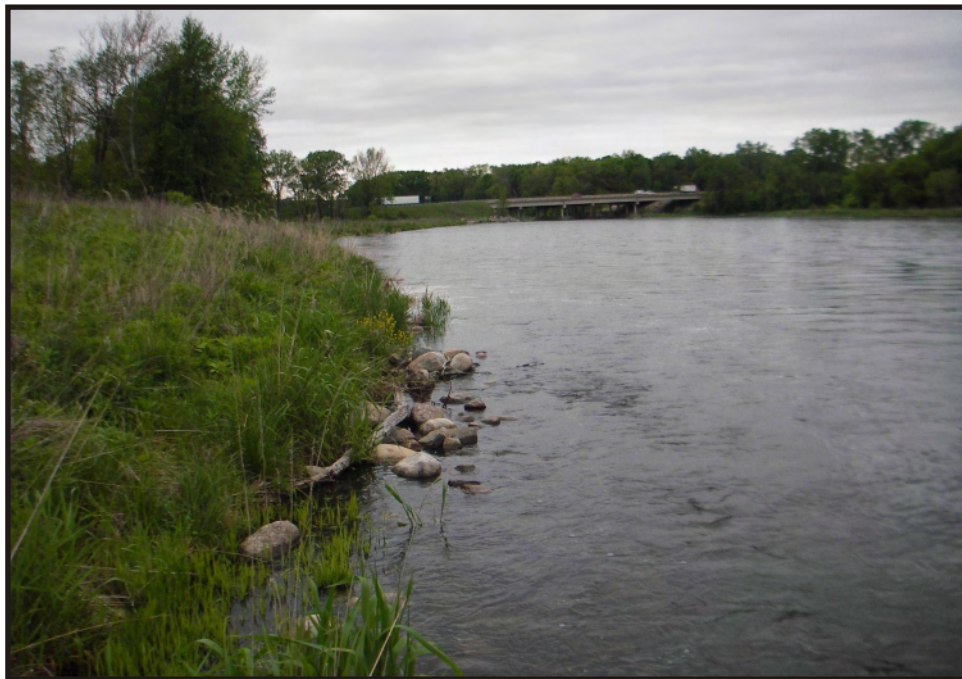
**18**

**Photo #18:** BEHI Area O1 (Low Erosion Potential) on south bank upstream of the US-131 bridge, looking west.

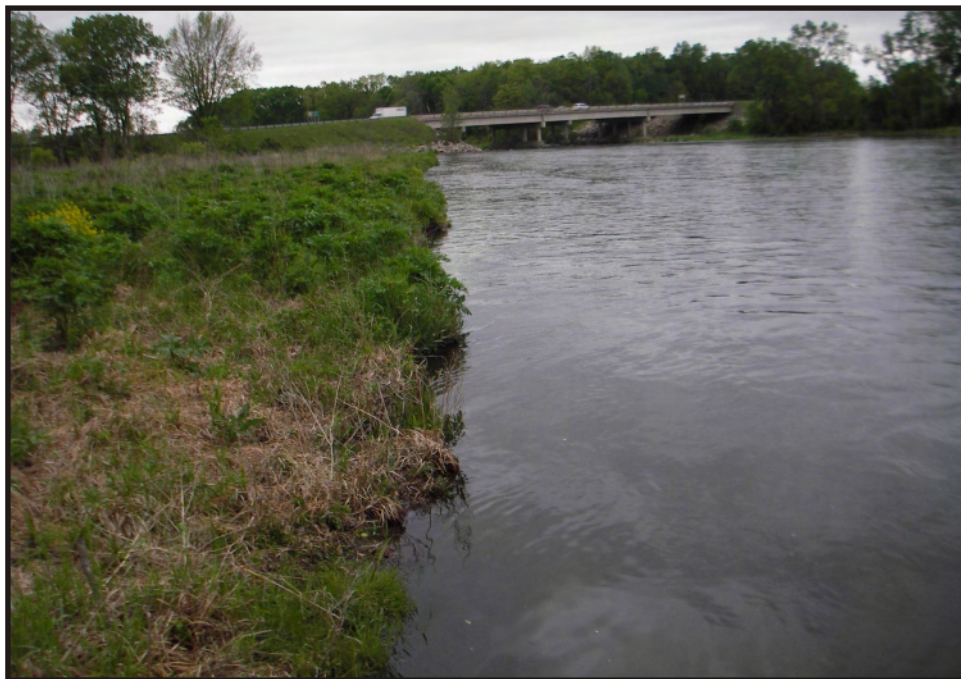
**19**

The portion of the south bank immediately upstream of the US-131 bridge (Labeled J1 on Figure 11) exhibited denser and deeper-rooted vegetation in 2010 than was observed in 2009. In addition, the bank angle in this area flattened from 69° to 60°. These improved characteristics decreased the BEHI rating for this section of bank from Moderate in 2009 to Low in 2010.

**Photo #19:** BEHI Area J1 (Low Erosion Potential) on south bank immediately upstream of the US-131 bridge, looking northwest.

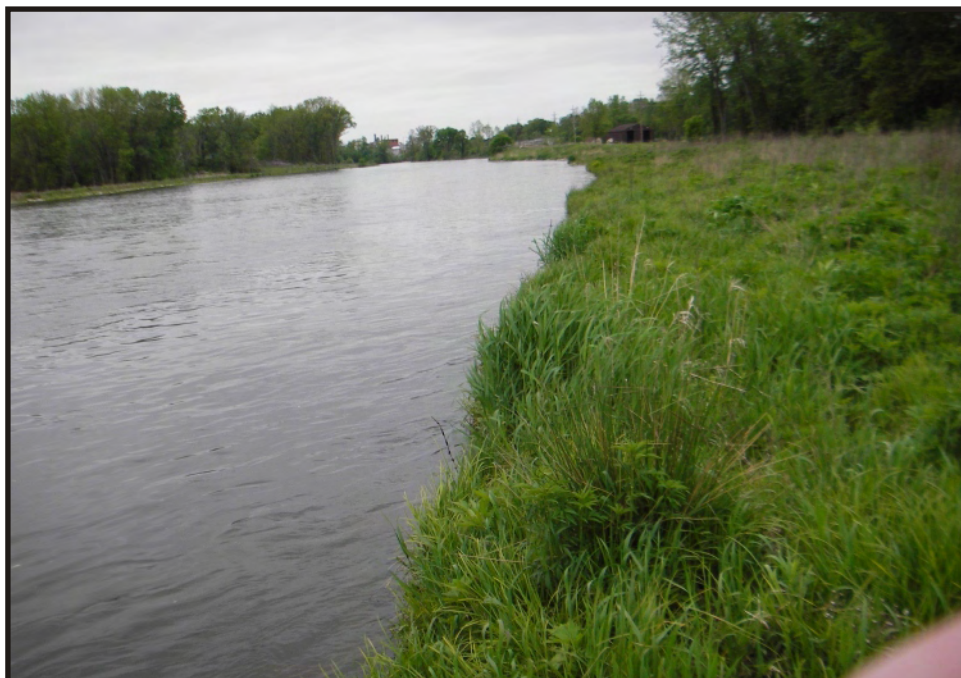
**20**

**Photo #20:** BEHI Area J1 (Low Erosion Potential) on south bank upstream of the US-131 bridge, looking southeast.

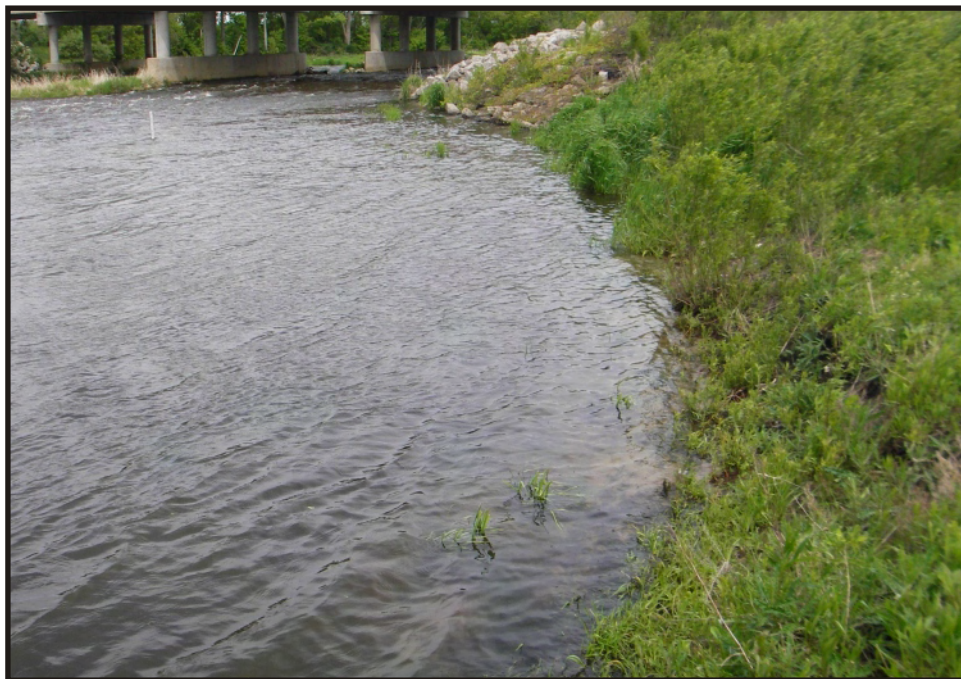
**21**

**Photo #21:** BEHI Area A2 (Moderate Erosion Potential) on south bank downstream of the US-131 bridge, looking southeast.

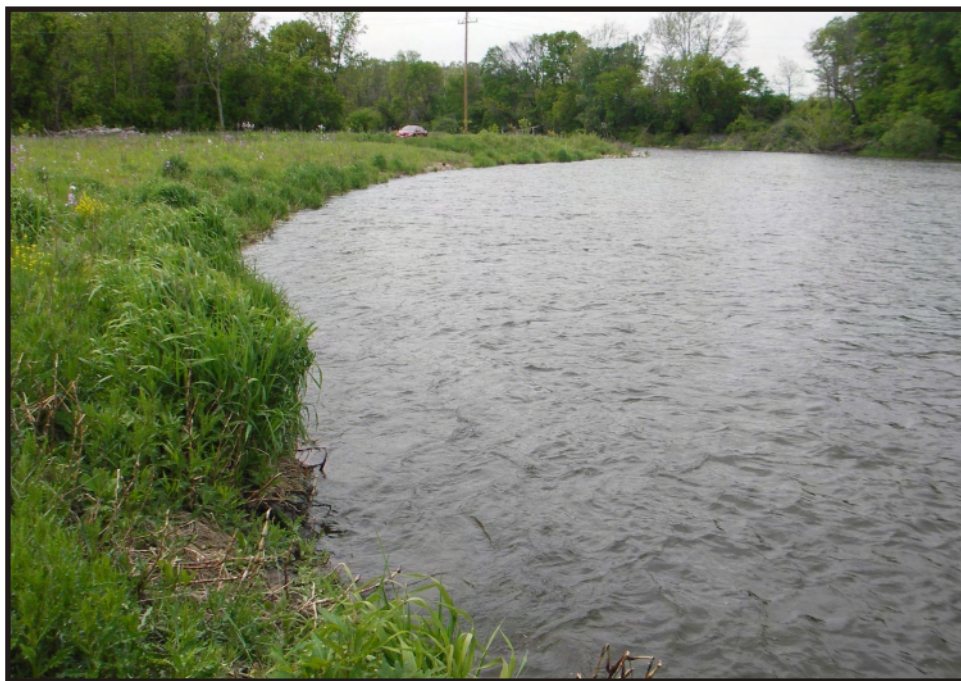
**22**

**Photo #22:** BEHI Area N1 (High Erosion Potential) on south bank downstream of the US-131 bridge, looking northwest.

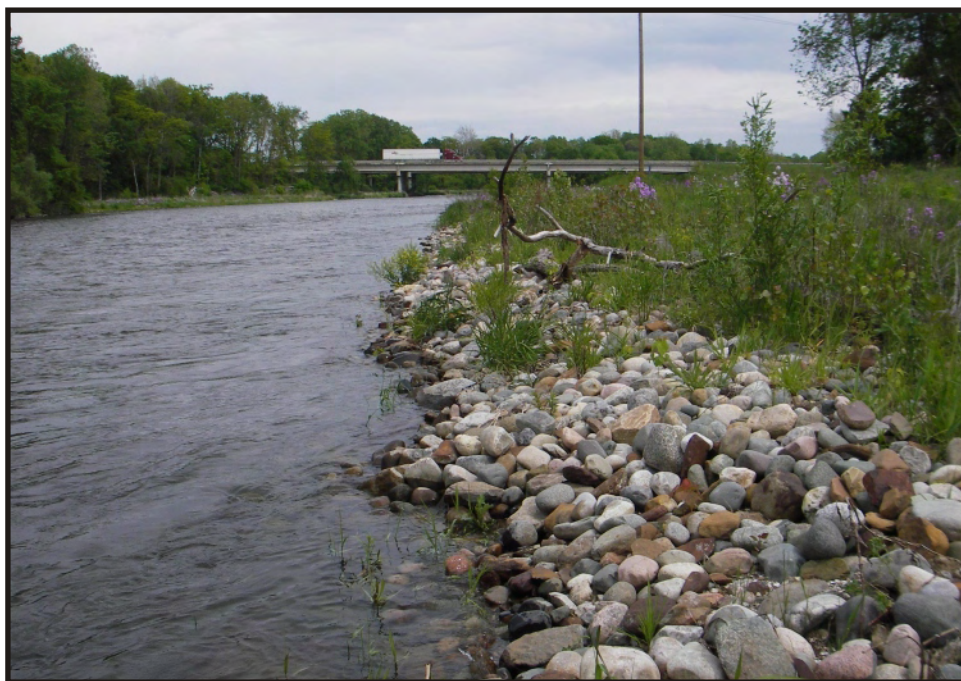
**23**

**Photo #23:** BEHI Area O2 (Low Erosion Potential) on south bank downstream of the US-131 bridge, looking east.

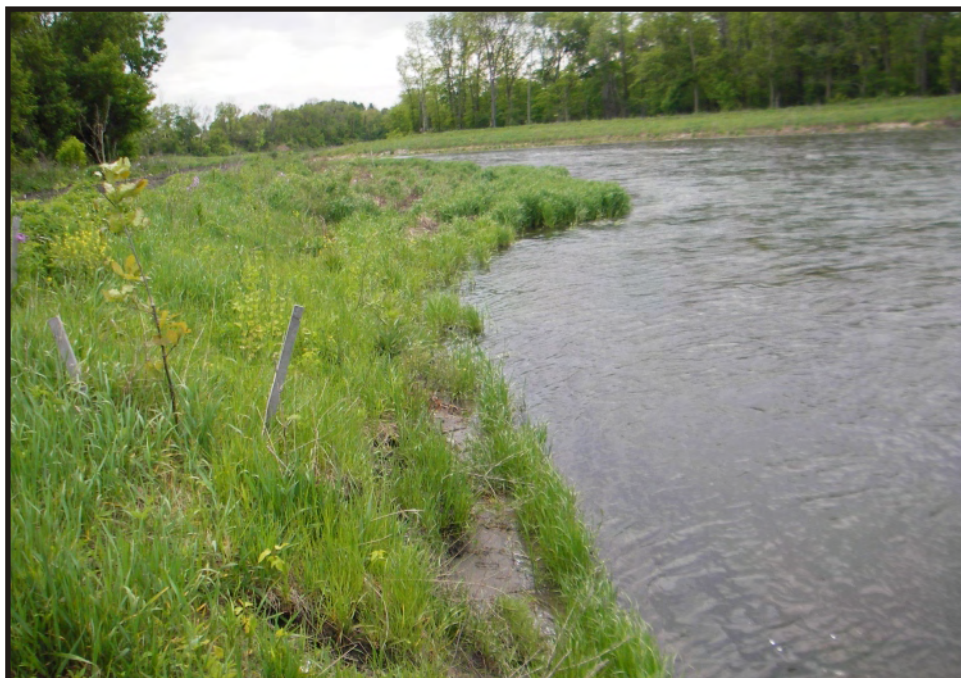
**24**

**Photo #24:** BEHI Area J2 (Low Erosion Potential) on south bank downstream of the US-131 bridge, looking southwest.

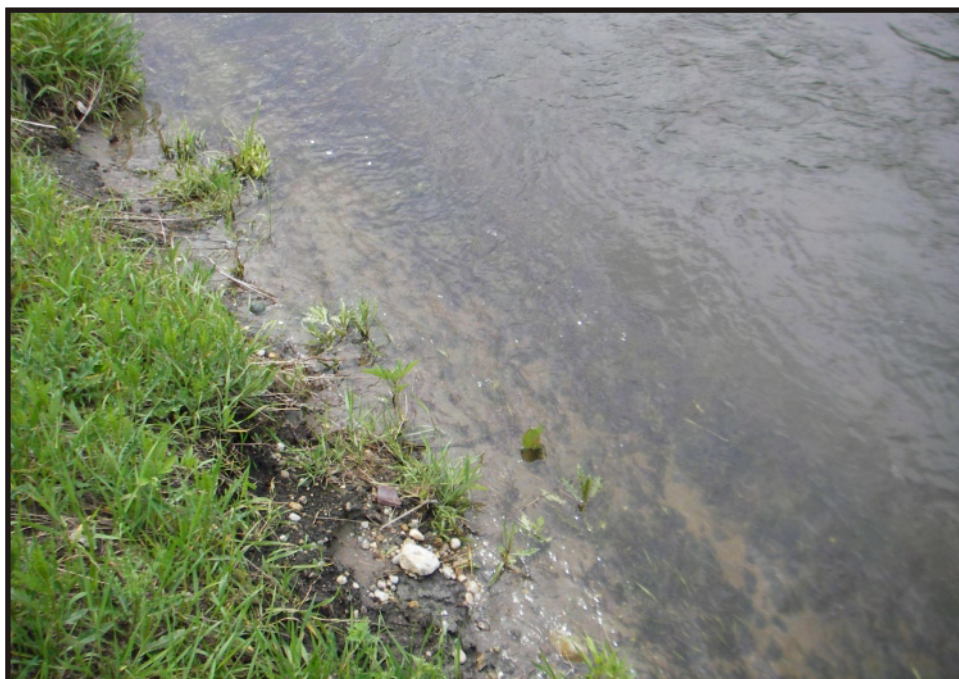
**25**

In 2009, a portion of the south bank upstream of the former Plainwell Dam at the former locations of Removal Areas 8B and 9B were concluded to require repair due to excessive erosion. The repairs implemented in fall 2009 consisted of placing river run rock from the remaining top-of-bank shelf to the river bed at an approximate 2:1 (horizontal:vertical) slope. The rock placement was similar to the bank repair performed in Removal Area 7, where rock was placed using a long reach excavator from the south bank. In addition to the rock toe protection, the remaining portions of the shelf behind (landward) the rock were provided additional erosion protection by the installation of a coir log at the prism-out median water elevation, which is the interface of the rock toe protection and the shelf. The coir log is functioning to reduce the flood frequency to allow the establishment and protection of vegetation on the shelf to further stabilize the shelf. This repair resulted in an increase in surface protection which decreased the BEHI rating for the repaired portion of bank (Labeled J2 on Figure 11) from Moderate to Low.

**Photo #25:** BEHI Area J2 (Low Erosion Potential) on south bank repaired in 2009 with rock and coir log.

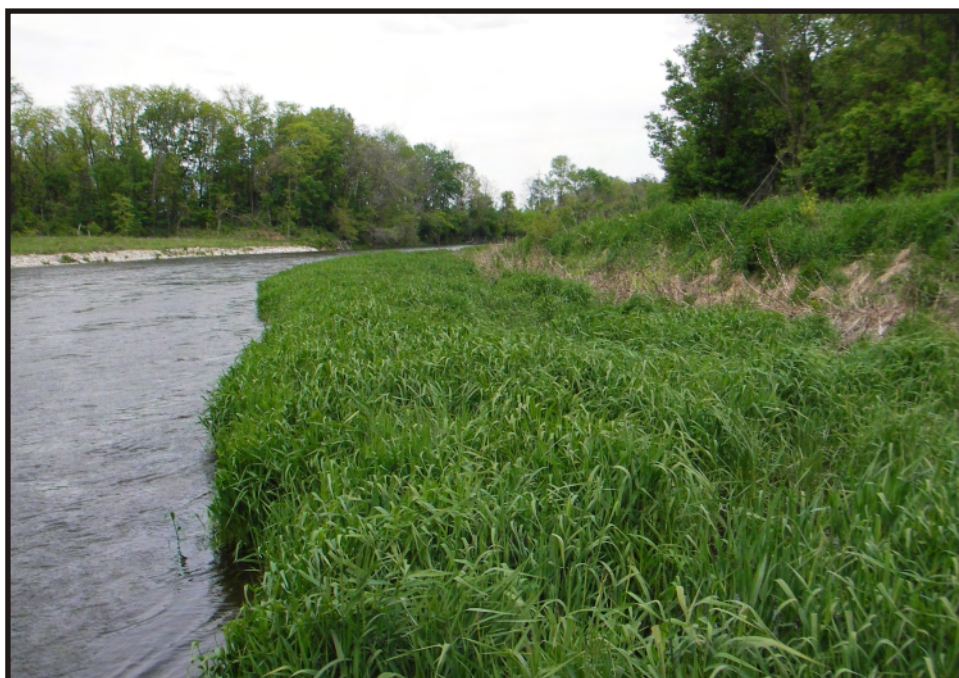
**26**

**Photo #26:** BEHI Area J2 (Low Erosion Potential) on south bank, looking northeast.

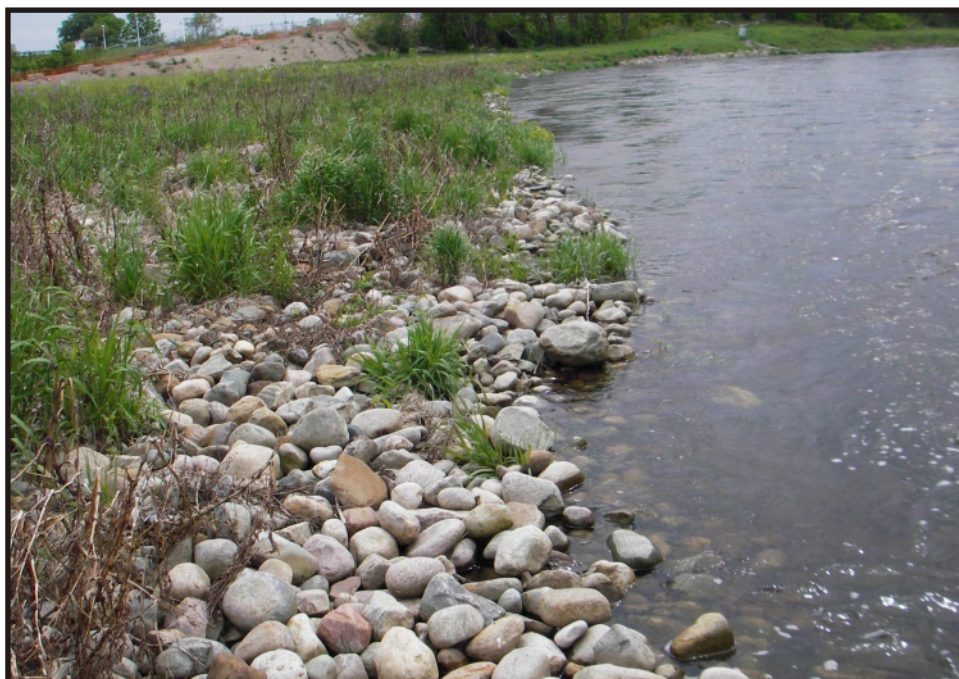
27

**Photo #27:** Downstream end of BEHI Area J2 (Low Erosion Potential) on south bank, looking southwest.

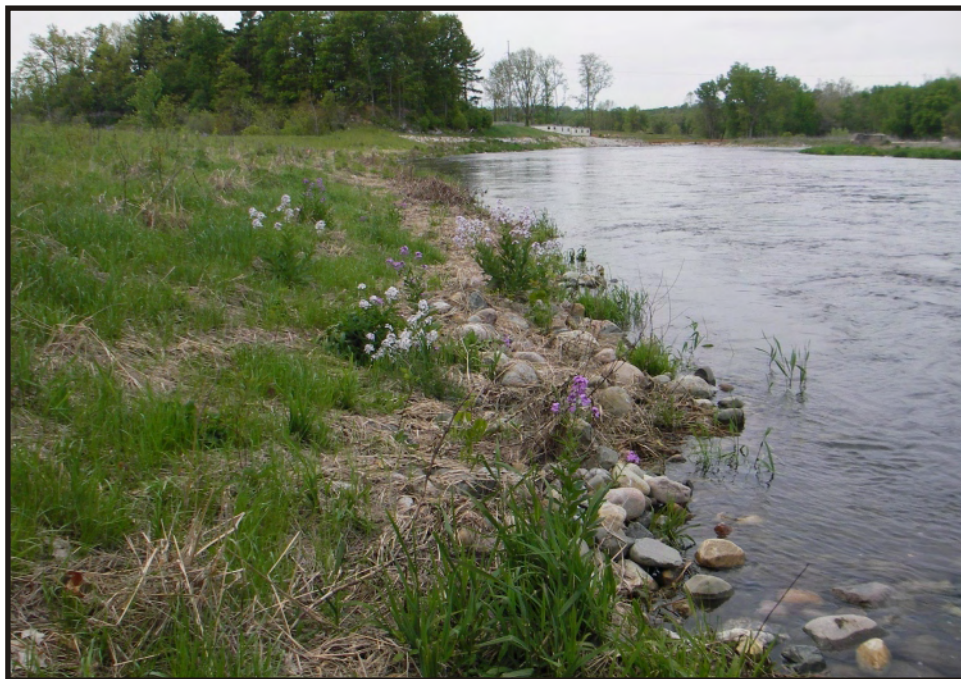
29

**Photo #29:** BEHI Area O3 (Low Erosion Potential) on south bank upstream of the former Plainwell Dam, looking northwest.

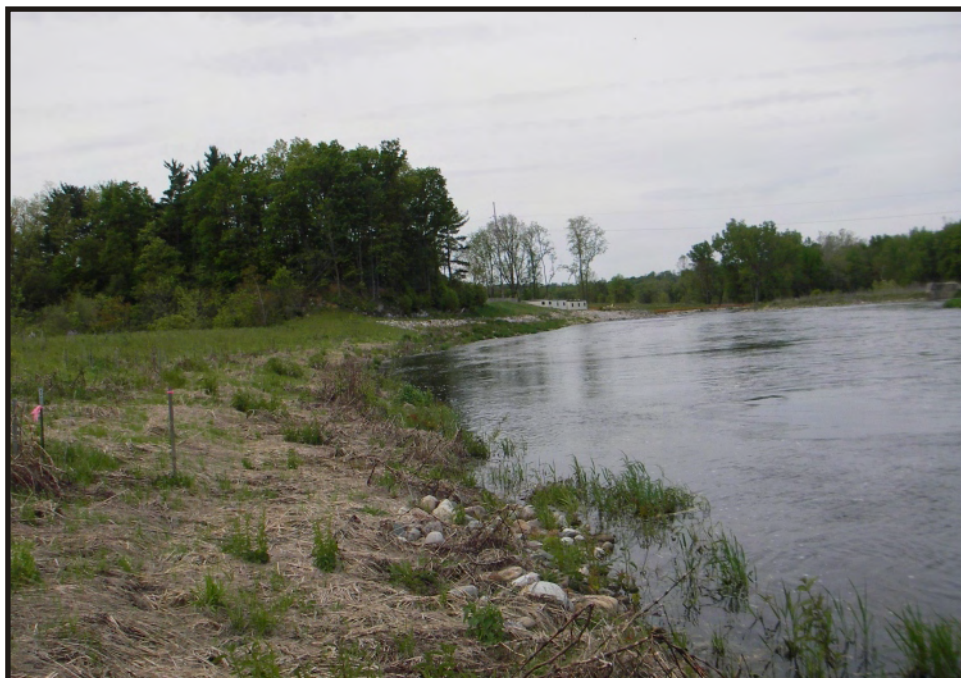
30

**Photo #30:** BEHI Area K1 (Low Erosion Potential) on south bank upstream of the former Plainwell Dam, looking northwest.

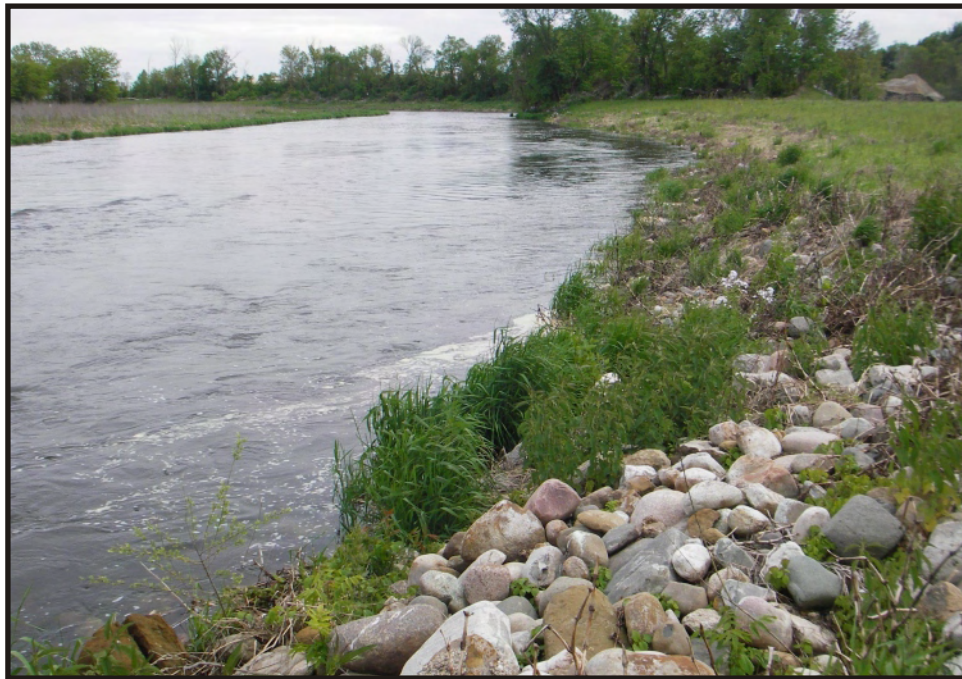
**31**

**Photo #31:** BEHI Area K1 (Low Erosion Potential) on south bank upstream of the former Plainwell Dam, looking southeast.
